# SOLVING AN ORTHO DISASTER

Lack of proper hygiene during orthodontic treatment spelled trouble for this young 16-year-old.  
By Luke Kahng Dentistry by Dr. Chris Pottorff

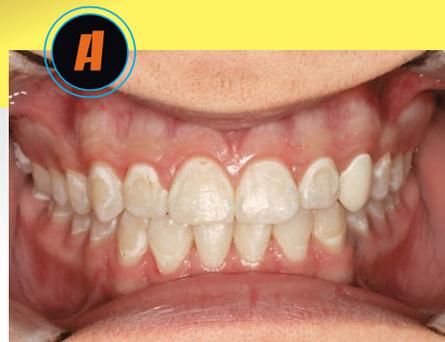
The patient presented with severe de-calcification and was unhappy with the shape of the central incisors.

After a 6-month period, during which the patient's hygiene was monitored with marked improvements noted, the patient was re-evaluated for anterior restorations (Figs. A and B). Upon examination, it was decided that due to severe decalcification and decay full coverage porcelain crowns were the treatment of choice.

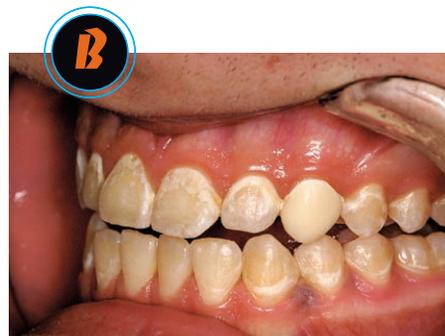
A "before" lateral view, showing decalcification and small lateral size

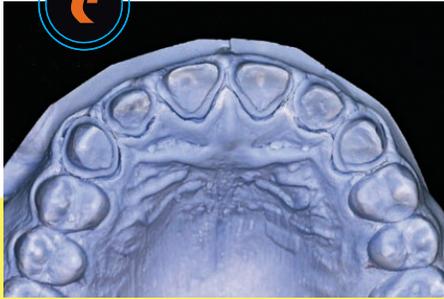
**C**

Occlusal view of master model, The preparations are designed with deep chamfer margins.

The teeth were prepped and impressions sent to dental laboratory (Fig. C). The dental team decided to use GC Initial PC, a pressed ceramic with veneering porcelain (Fig. D). Pressed ceramics result in a metal-

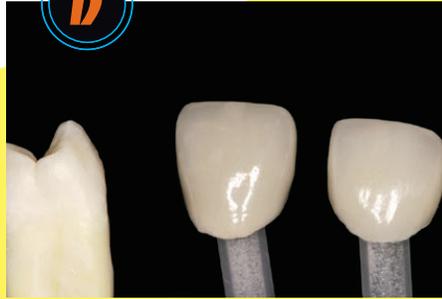
**D**

A natural tooth, porcelain to metal crown, and GC Initial PC crown are compared.

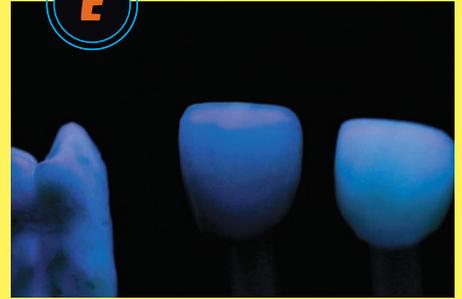
**E**

The teeth shown are shown under ultraviolet light.

free restoration high in translucency. Due to the patient's youth, a highly translucent restoration was needed (Fig. E).

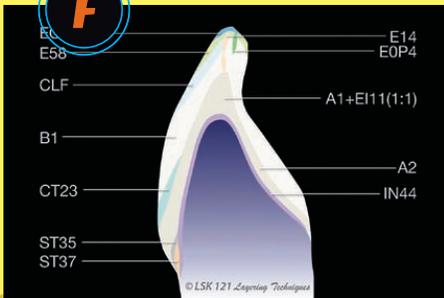
**F**

Laboratory's computer-generated shade mapping is completed by the dental technician.

technician completed a shade map using a multi-colored layering porcelain application (Fig. F).

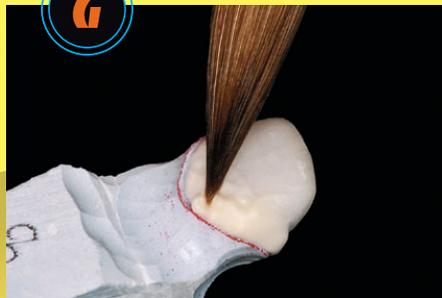
**G**

Porcelain labial margin is added using GC Initial porcelain. This helps control the translucency.

The technician fabricated the pressed ceramic copings and decided on porcelain labial margins for more control over the amount of translucency at the gingival area. Margins were creating using GC Initial LF. This specially developed shoulder powder allows the technician to control translucency and blend in with the framework shade (Fig. G). Other special powders in the GC Initial line such as Fluorescence Dentin help the technician provide the highest in esthetics by applying porcelain at the incisal in the light refraction area (Fig. H).

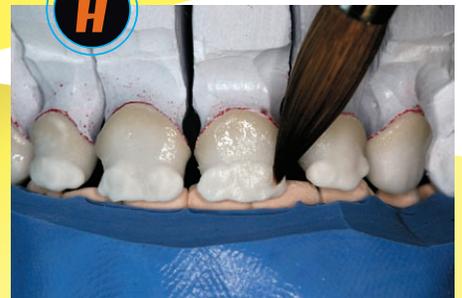
**H**

Fluorescent dentin porcelain is used as a foundation. Shade FD91 is applied at the incisal not showing too much translucency.

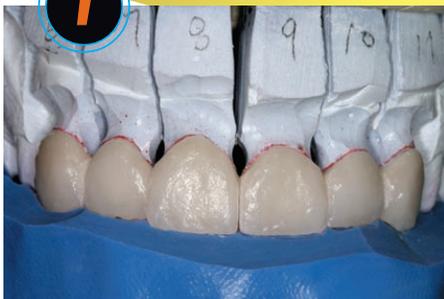
**I**

The fired crowns are checked with the putty matrix.

The multi-layered porcelain build-up of the restorations was completed. After the firing, the restorations were checked against the lab putty matrix (Fig. I) for length comparison to the treatment plan wax up. At this stage crown contours can be modified (Fig. J) to grant the patient's wish for symmetric centrals. By studying extracted permanent

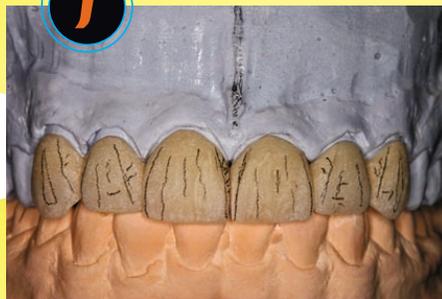
**J**

Bisque bake stage checks same symmetry, long axis, mid-line, and silhouette.<sup>1</sup>

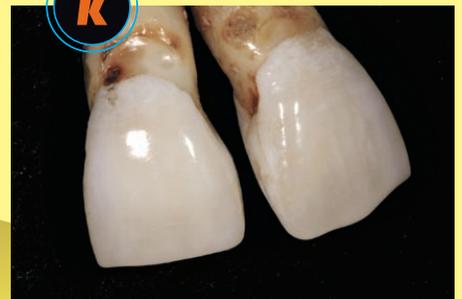
**K**

Natural teeth\* always give a good hint for emergence profile and color blending. (\*Donated by Dr. David Schubert, Plainfield, IL)

teeth (Fig. K), the technician can see the natural emergence profile and contour as well as the color blending.

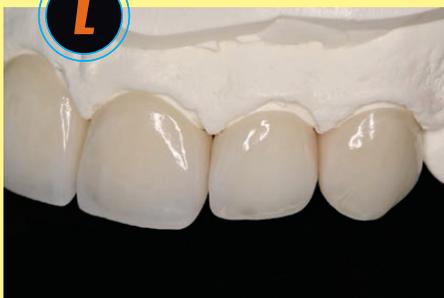
**L**

Silhouette opens more toward the canine to give a natural looking appearance.

The technician must use this knowledge in fabricating restorations, while respecting the requests of the dental team (dentist, patient, and technician). Silhouette also must be considered. This plays an important role in the tooth appearance since the spacing at the incisal edge near the contact area will vary from tooth to tooth (Fig. L).

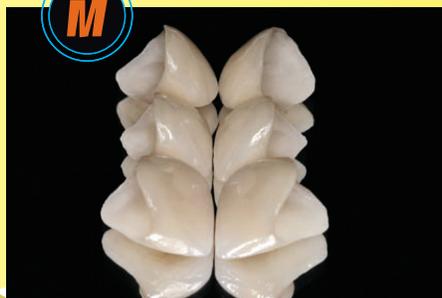
**M**

Finished GC Initial PC crowns with GC Initial LF Porcelain.

The finished crowns (Fig. M) were highly esthetic. The technician was also able to control the value of the material due to its high translucency. Harmony in texture and color (Fig. N) also was achieved.

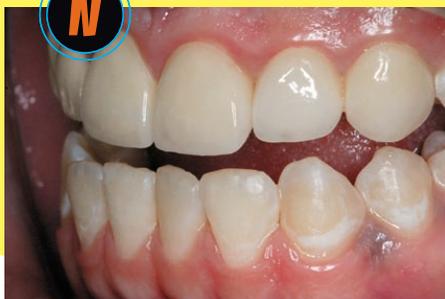
**N**

Immediate lateral view demonstrates color and shape harmony.

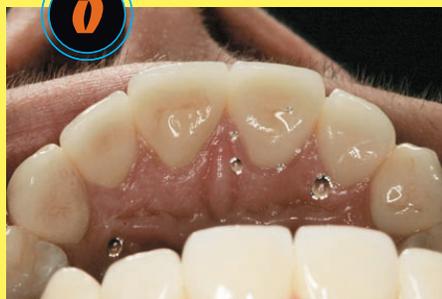
**O**

Occlusal view.

In addition, the dentist and technician were careful to add function to the equation, which helps aid in the longevity of the restorations (Fig. O). The patient's vision of his perfect smile was applied with beautiful results (Fig. P). Preoperatively, his forced smile hid his imperfections, but postoperatively a full and confident smile shines from his happy face (Fig. Q).

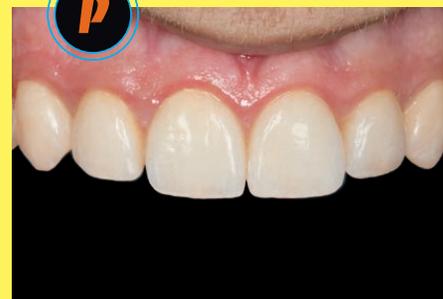
**P**

The centrals, #8 and #9, are symmetrical.

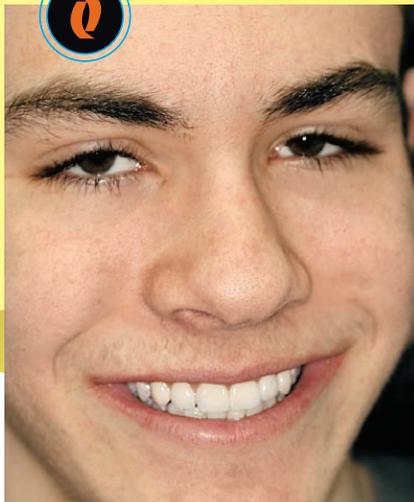
**Q**

"After" full facial view.
