# Esthetic Restorative Treatment Options for the Broken Anterior Ceramic Restoration

Wynn H. Okuda, DMD

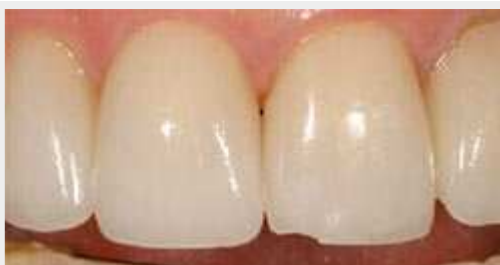
**Figure 1** Chipped porcelain in the anterior region is a common problem that can occur in the general practice.

*Esthetic dental problems* can happen every day. Broken ceramic restorations in the anterior region is a common problem that can occur in the general practice (Figure 1 [View Figure](#)). Because of the visual nature of the problem, patients call the dental practice distressed and want immediate correction. When this occurs there can sometimes be more than one option for correction. This article will look at this common esthetic problem and the clinical treatment options for its correction.

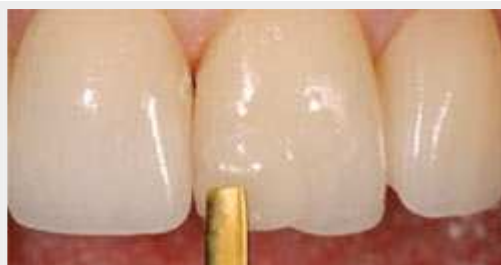
**Figure 2** A nano-hybrid composite resin is placed and sculpted to repair the chipped porcelain.

Ceramic restorations use shaded porcelain powders and modifiers to mimic tooth coloration. Therefore, in situations where broken ceramic restorations need to be repaired, a composite resin with a “chameleon effect” is needed to esthetically blend to the porcelain restoration. In addition, having a composite material that has little to no

polymerization shrinkage provides a seamless restorative interface between the ceramic and composite resin material (Figure 2 [View Figure](#)).

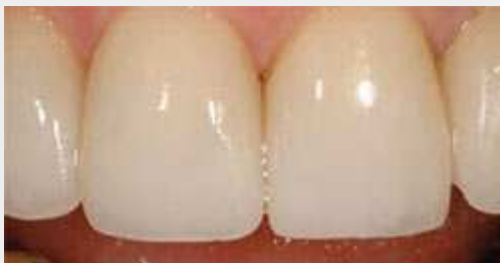
**Figure 3** The ceramic restoration is restored with a minimally invasive composite resin restoration.

Recently, dental science has responded with new advancements in composite resin technology. With the latest generation of nano-hybrid composite resins a new plateau in cosmetic-restorative dentistry has been reached (Figure 3 [View Figure](#)).

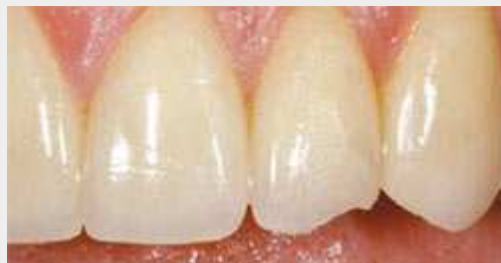
**Figure 4** The ceramic restoration is chipped from excessive lateral excursive stress.

If the majority of the ceramic restoration is intact and viably strong, a minimally invasive (MI) restoration can be a viable long-term solution (Figure 4 [View Figure](#)). A Class IV composite resin restoration can correct this problem in one appointment. There are several critical steps in performing an invisible Class IV restorative repair. Correct preparation design is one of the keys to success in creating an invisible composite resin restoration. A long bevel is placed along the facial margin so there is a good transitional blending of the composite resin to the ceramic surface.

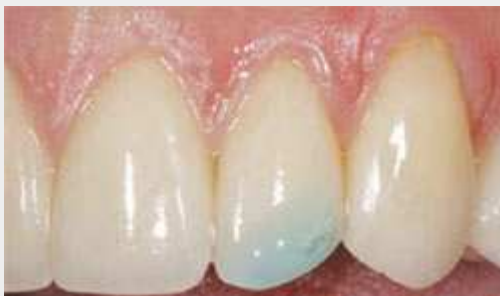
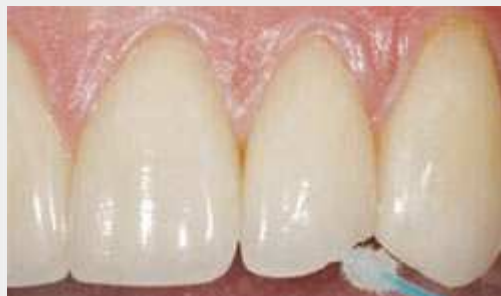
**Figure 5** Conditioning of the ceramic restoration with phosphoric acid acidifies and cleanses the restorative surface before placing porcelain repair adhesive.

Next, micro-etching with aluminum oxide (eg, Micro-etcher II, Danville Engineering, San Ramon, CA) is completed on the porcelain surface to be restored to create micro-mechanical retention. Then acid-etching with 32% phosphoric acid is done to acidify the bonded surface (Figure 5 [View Figure](#)). An adhesive with a silane coupling agent (eg, Porcelain Repair Kit, BISCO Inc, Schaumburg, IL; Clearfil® Repair, Kuraray America, New York, NY; RelyX® Ceramic Primer, 3M ESPE, St. Paul, MN) should be used to chemically adhere the composite resin to the sand-blasted ceramic restoration (Figure 6 [View Figure](#)).

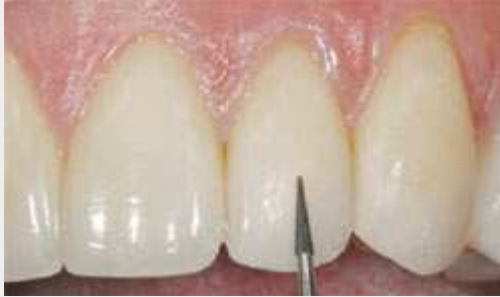
**Figure 6** An adhesive with a silane coupling agent is used to bond the composite resin to the ceramic restoration.

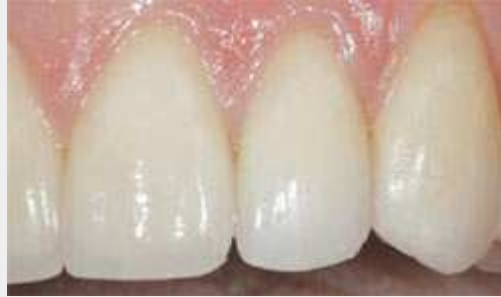
**Figure 7** After restoring the chipped ceramic with a nano-hybrid composite resin, finishing carbide burs are used to refine the restorative surface.

Then, a nano-hybrid (eg, Aelite™, BISCO; Filtek™ Supreme Plus, 3M ESPE) composite resin material is used to regain both strength and esthetics. In a Class IV restoration, composite resin with a good depth of shade and chameleon effect are crucial so that an invisible margin can be achieved. Using technologically advanced materials are important for ease of finishing and polishing. By using predictable finishing carbides (eg, Composite Finishing Kit system, Brasseler USA, Savannah, GA), finishing strips (eg, Epitex, GC America) and polishing discs (eg, Soflex Extra-Thin [XT] finishing discs, 3M ESPE; EP Esthetic Polishing

System, Brasseler USA) a natural surface finish can be created (Figure 7 [View Figure](#)). Finally, aluminum oxide polishing pastes (eg, Micro-diamond polishing paste, Ultradent Products, South Jordan, UT; Tru-Luster, Brasseler USA; Enamelize™, Cosmedent, Chicago, IL) with a soft goat-hair chamois (eg, LusterPro, Brasseler USA) can recreate a natural luster on the restorative surface (Figure 8 [View Figure](#)).

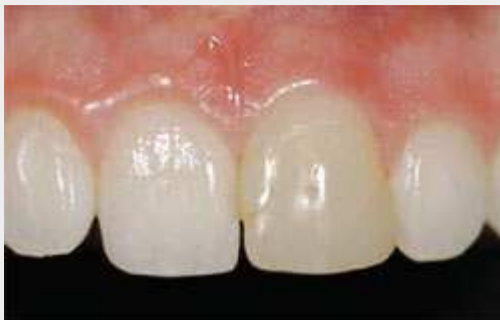
**Figure 8** With the next generations of nanohybrid composite resins, an invisible restoration can easily be achieved.

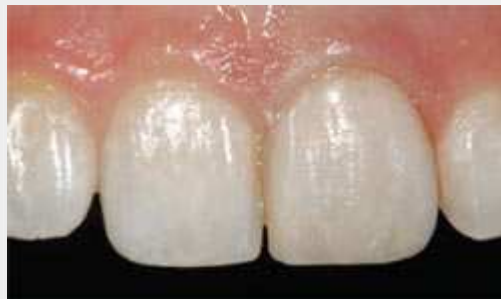
**Figure 9** A broken and discolored ceramic restoration can be repaired with minimally invasive treatment.

For a broken ceramic restoration that also needs to have refurbishment of the facial surface, a composite resin veneer is a viable treatment option (Figure 9 [View Figure](#)). This would still be considered a MI procedure. The preparation design is similar to the Class IV; however, it also includes a light preparation on the entire facial surface. Approximately 0.2 mm to 0.4 mm of preparation should be done to properly restore the tooth.

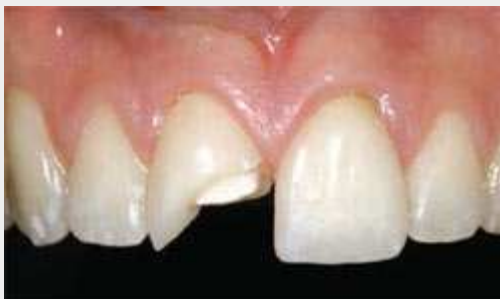
**Figure 10** A minimally invasive composite veneer was used to refurbish this ceramic restoration.

With the use of finishing discs as well as finishing and polishing burs, the composite veneer can be properly finished to the existing ceramic restoration. In the same way as the Class IV restoration, the composite veneer can be a long-term conservative treatment solution in the repair of a moderately damaged ceramic restoration (Figure 10 [View Figure](#)).

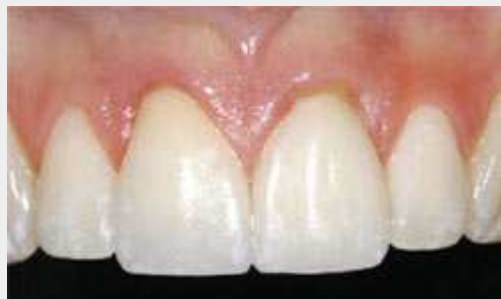
**Figure 11** Careful assessment of a

severely broken ceramic restoration is done before determining the optimal clinical treatment option.

In cases where the majority of the restoration is broken and the remaining ceramic restoration is compromised, a full replacement of the ceramic restoration should be considered (Figure 11 [View Figure](#)). Replacing a single ceramic restoration can be more difficult than repairing it with a conservative composite resin. Therefore, careful assessment should be taken before considering replacement of the ceramic restoration. However, if a new ceramic restoration is treatment planned, there are several important factors that need to be contemplated.
